IN THE WONDERLAND OF PERU

The Work Accomplished by the Peruvian Expedition
of 1912, Under the Auspices of Yale University
and the National Geographic Society

By HIRAM BINGHAM

Reprinted from the NATIONAL GEOGRAPHIC MAGAZINE, April, 1913

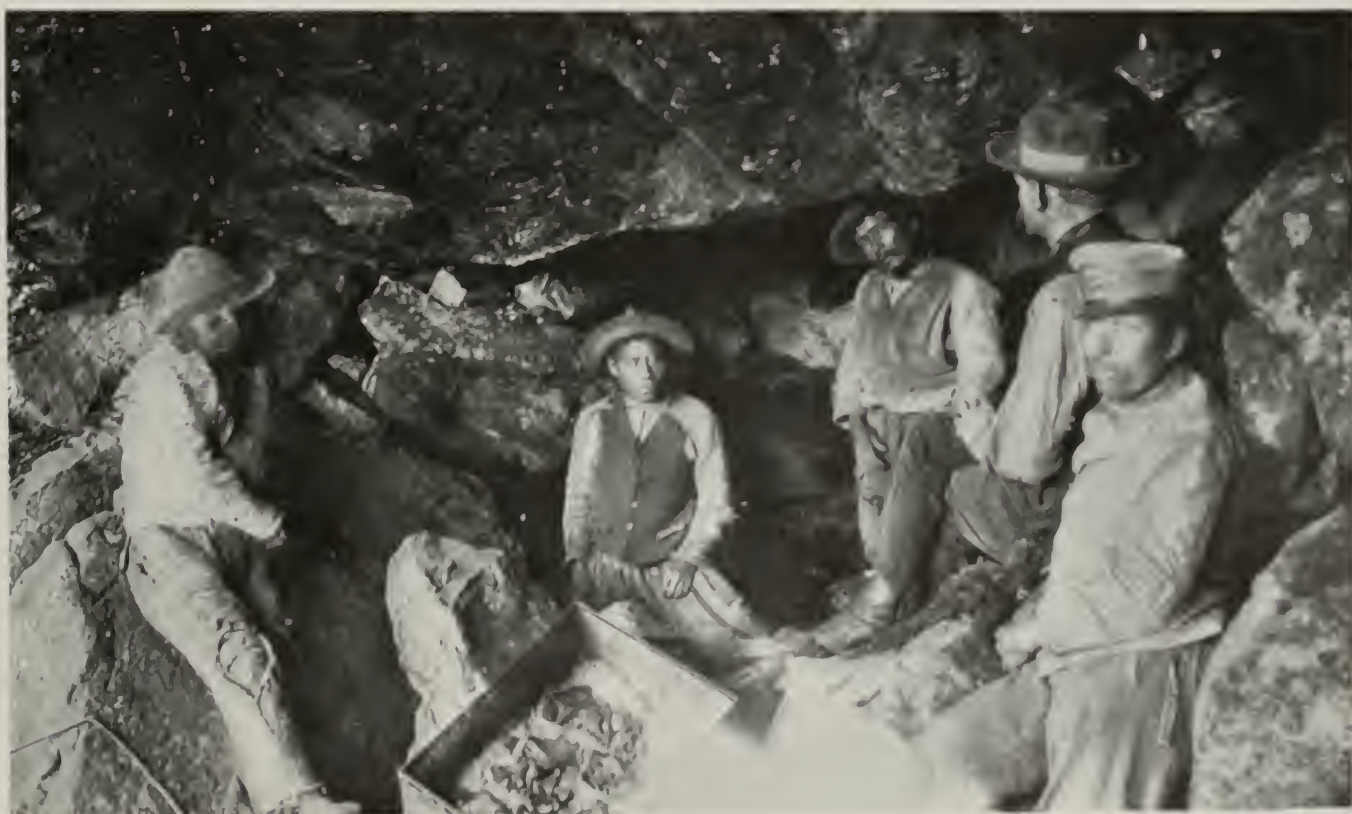
A flashlight view of cave No. 9, one of the larger burial caves, in the floor of which a number of skeletons were found. On the ground among the rocks were pieces of beautiful large pots, which may have been destroyed at the time of burial (see pages 446-447).

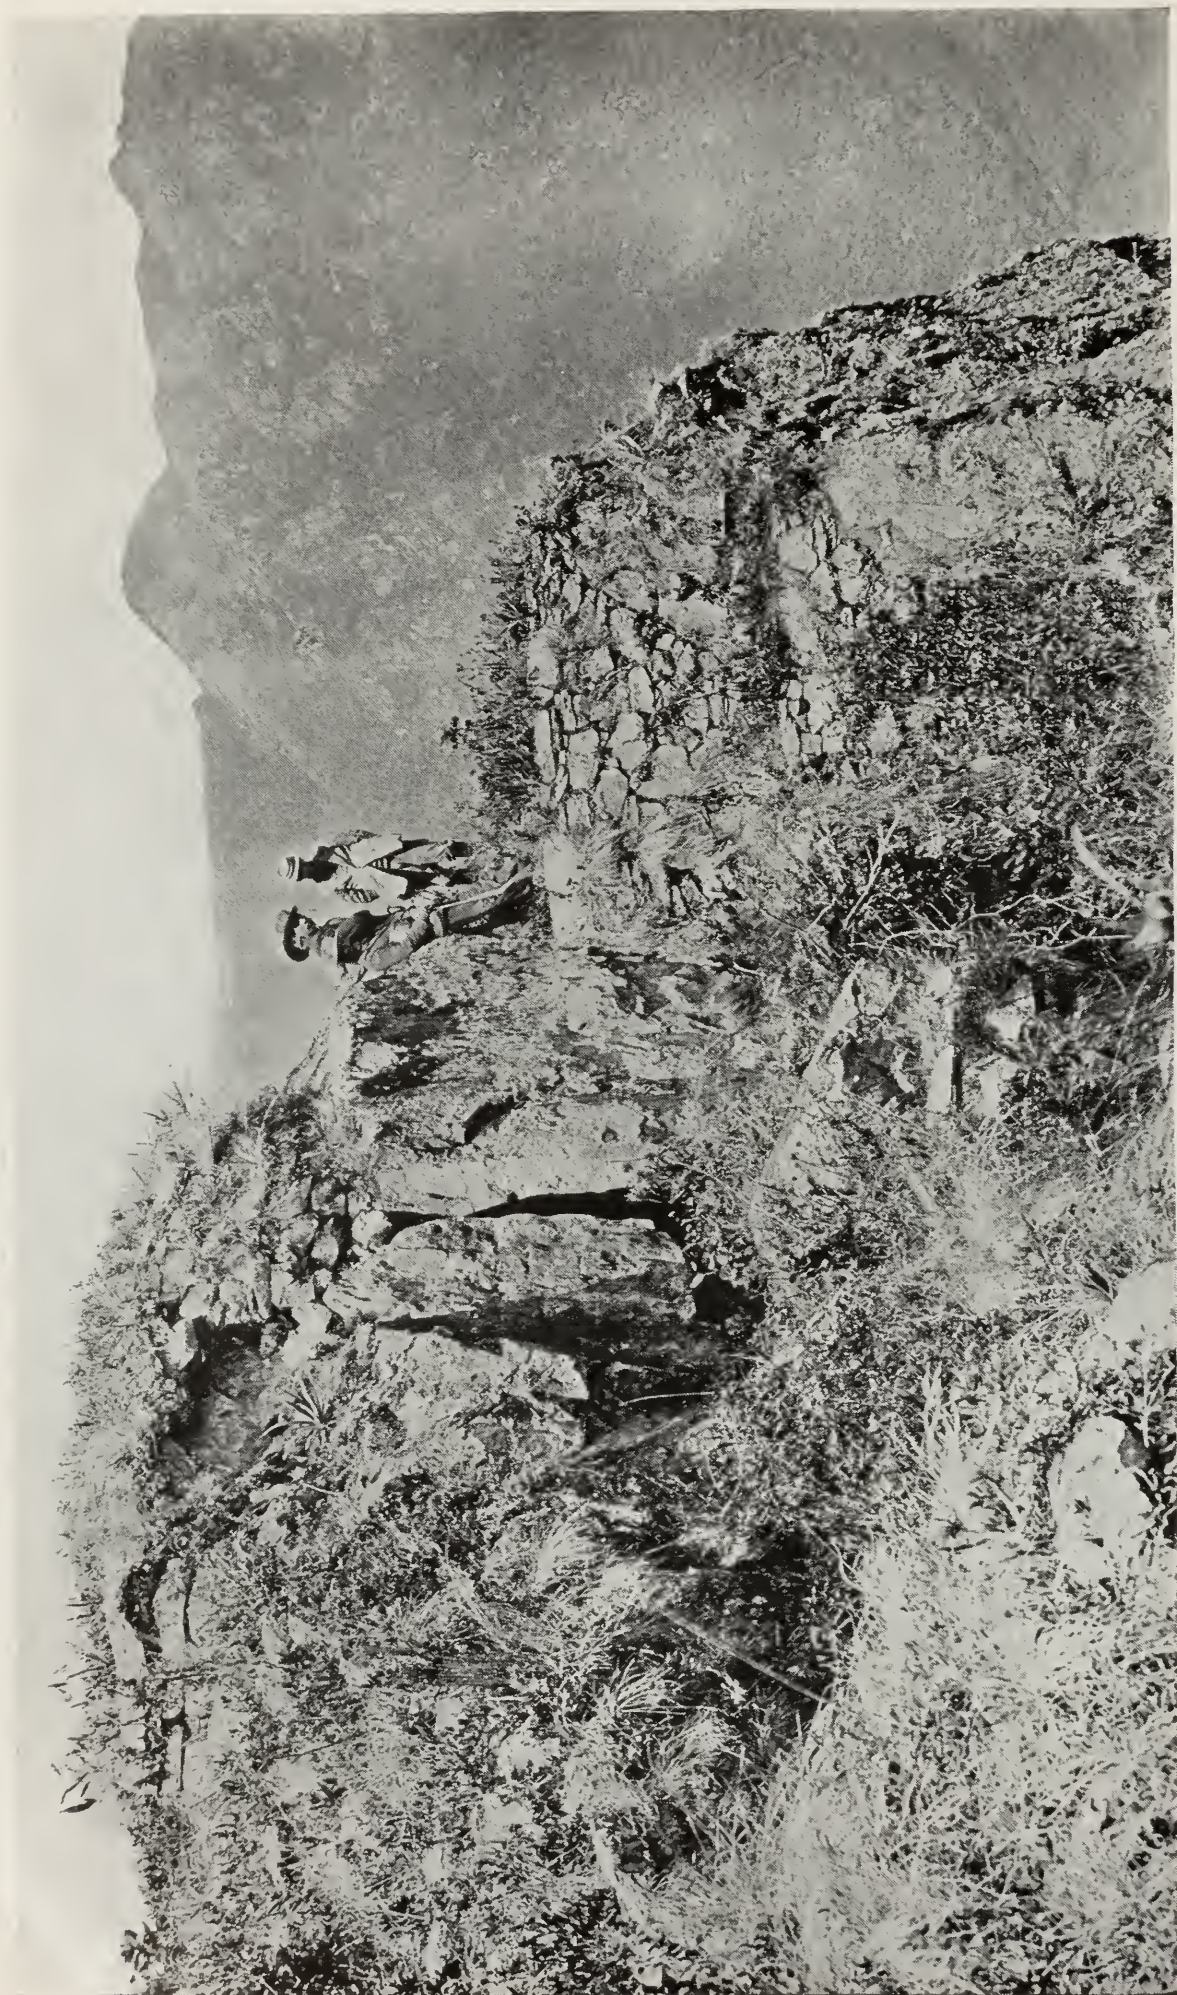
On the very summit of one of the most stupendous precipices the Incas constructed a signal station from which the approach of an enemy could be instantly communicated to the city below. By looking very carefully the terraced walls of this signal station may be seen just below the figures who are standing on an artificial platform (see pages 442 and 443).

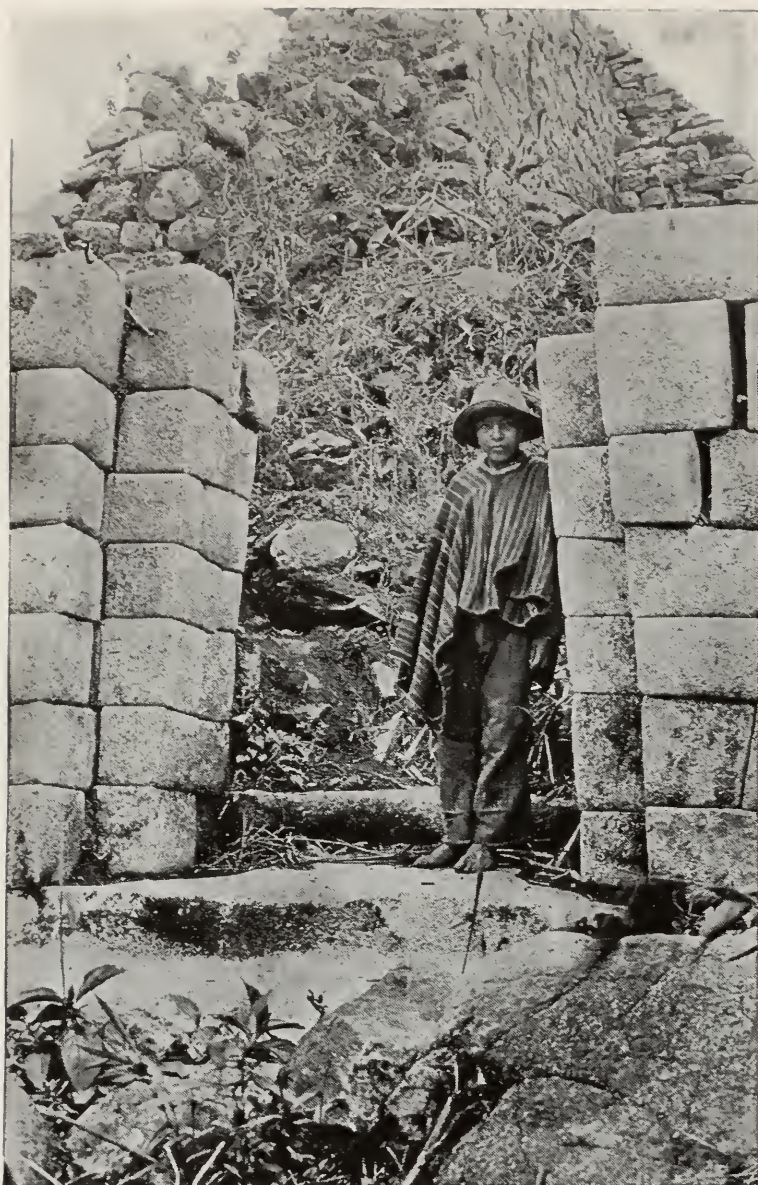
The detailed study (p. 488) of where the wall joins the next house wall shows how ingeniously the blocks were constructed, so as to form a brace which would prevent the house and wall from leaning apart and thus causing cracks to appear in the wall. The precision of line, the symmetrical arrangement of the blocks, and the gradual gradation in the tiers, with the largest at the bottom and the smallest at the top, combine to produce a wonderfully beautiful effect.

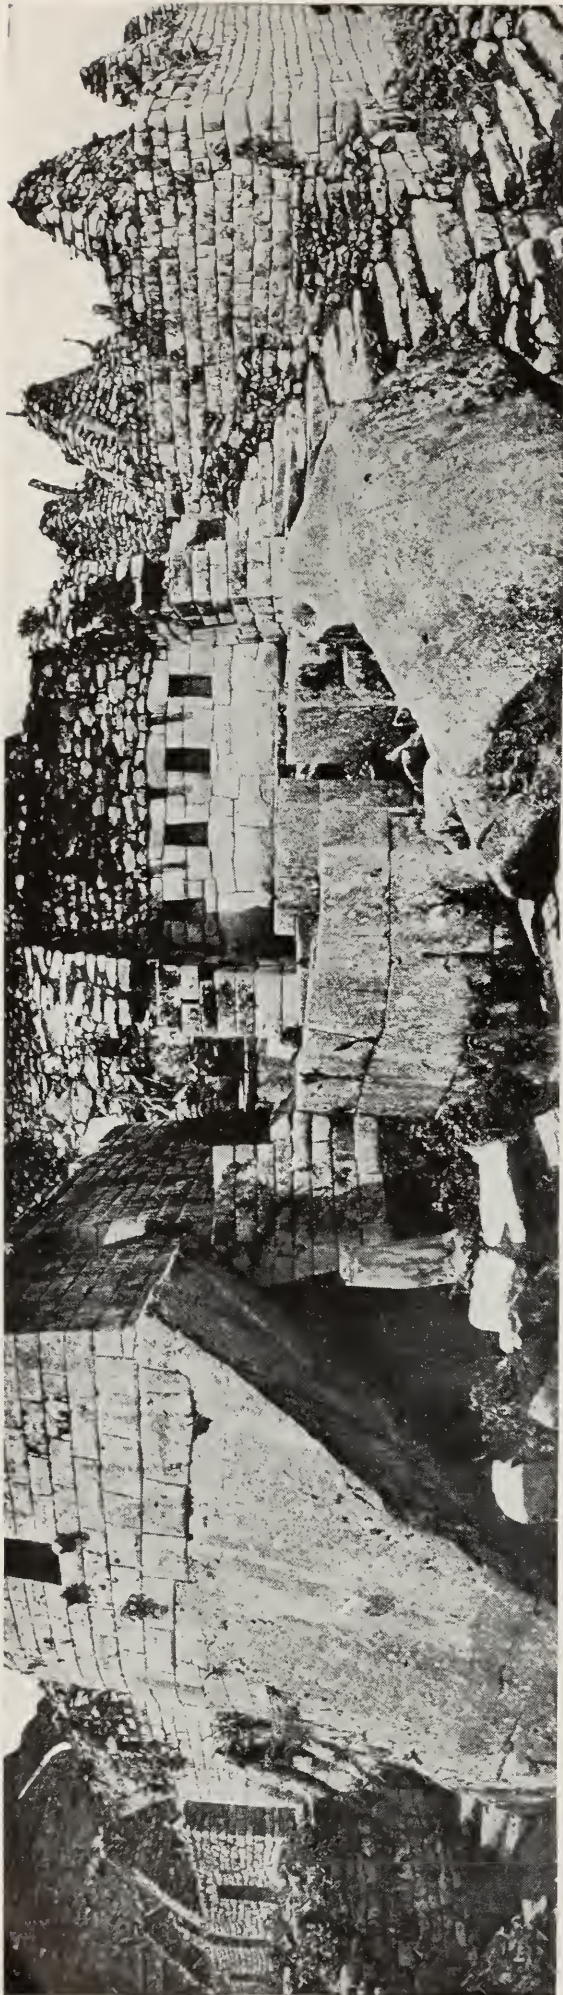
THE INTERIOR OF THE SEMICIRCULAR TOWER NEAR THE SNAKE WINDOW
The cracks in the walls were probably caused by a great conflagration centuries ago.
